# Track Maintenance Know-How

## Focus on ... Erosion Control and Water Bars

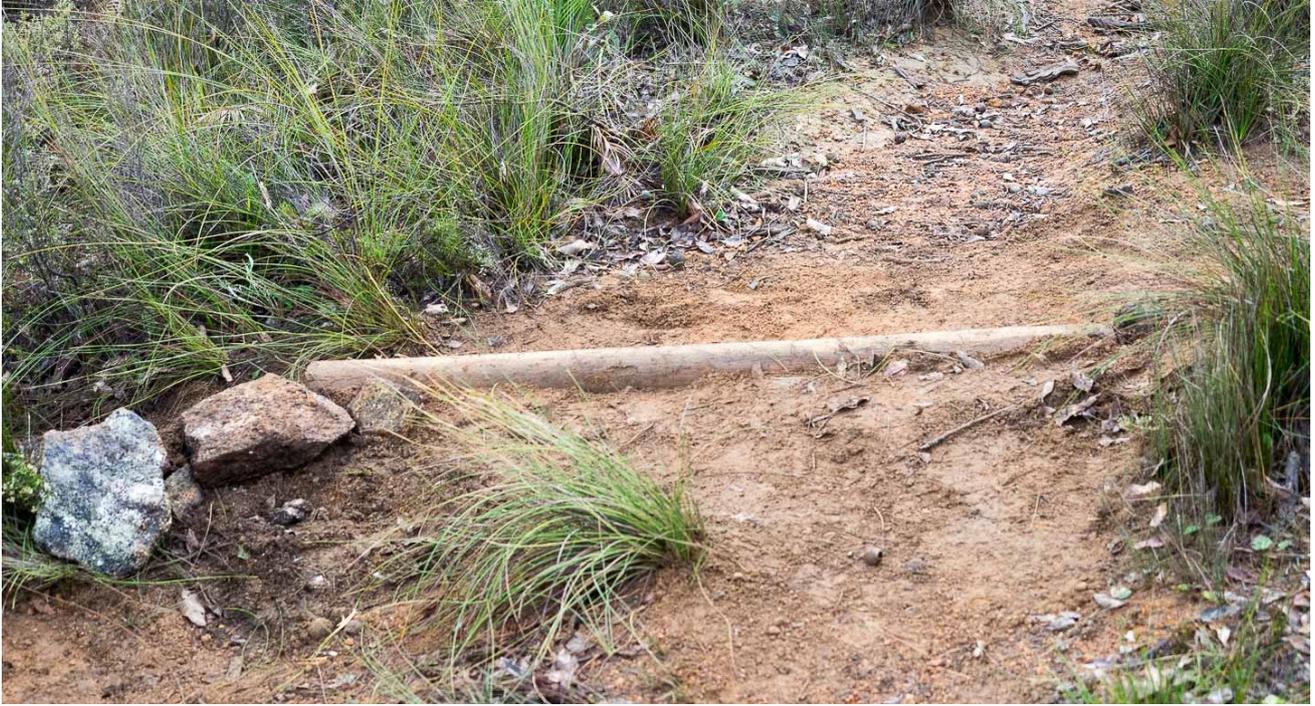
Water is one of the most difficult issues to manage. Poor drainage, steep slopes and high use can lead to a range of problems including pooling of water, tread instability and erosion channels. The effects of erosion are minimised by correct track construction techniques. A range of track construction, compaction and drainage techniques (water bars, culverts, etc.) have been applied to ensure a well-drained, stable surface on the Bibbulmun Track.

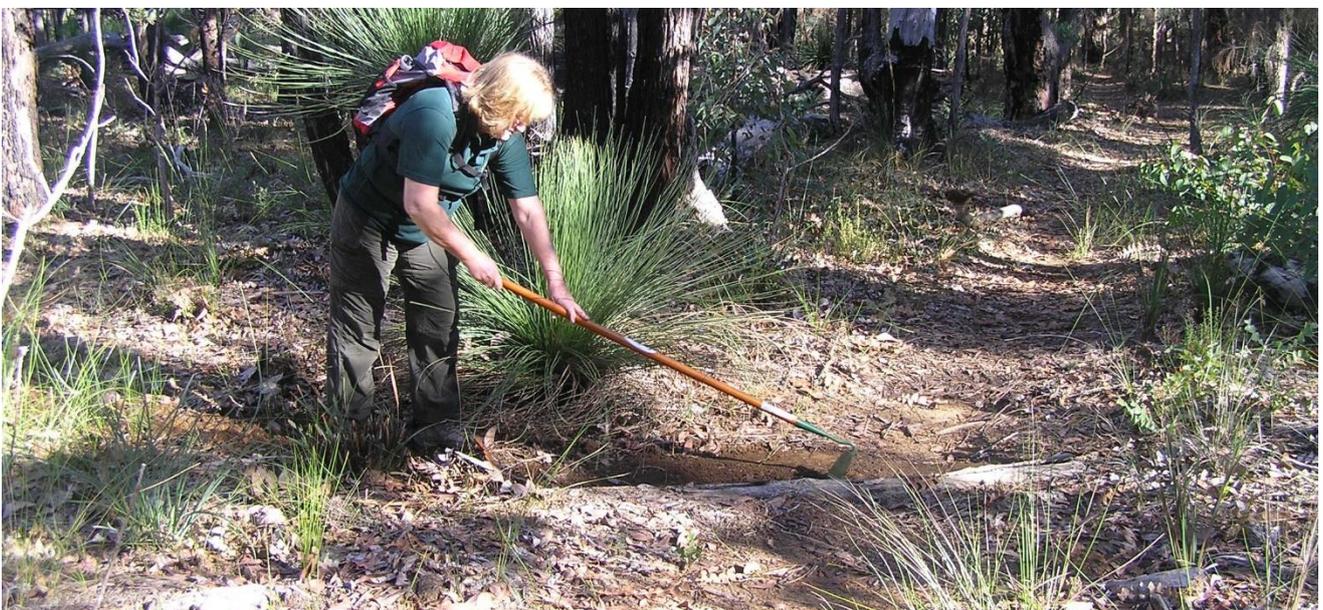
Water bars have been installed on various parts of the Track to minimise erosion. They are angled across the Track on sloping ground so that the water is channelled off the Track into the surrounding bush. Water bars may be made of wood or of the local soil (earthen).

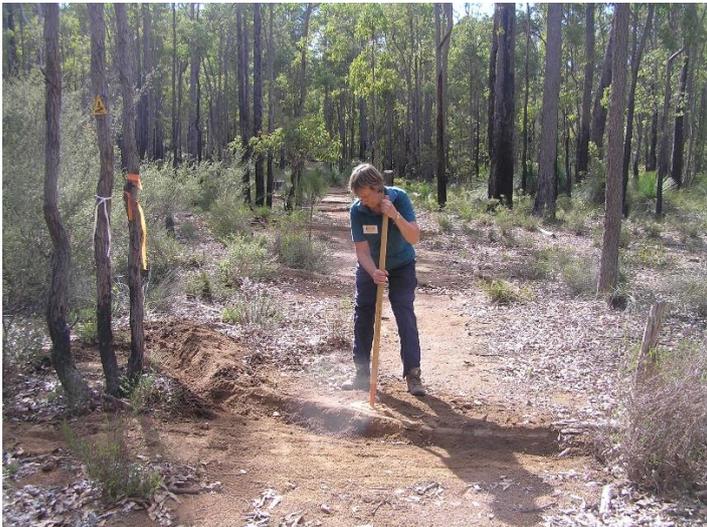
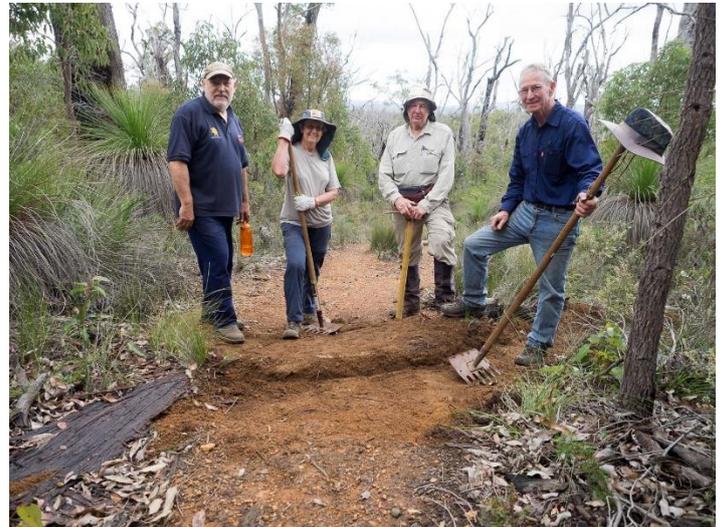
Look for...	Maintenance Tasks
<ul style="list-style-type: none"> <li>Water running around the top end of the bar</li> </ul>	<ul style="list-style-type: none"> <li>Either trench the ground to redirect the runoff, or replace with a longer bar</li> </ul>
<ul style="list-style-type: none"> <li>Water running around the bottom end of the bar</li> </ul>	<ul style="list-style-type: none"> <li>Either trench the ground to extend the runoff, or replace with a longer bar</li> </ul>
<ul style="list-style-type: none"> <li>Water running over the top of a wooden bar – due to soil build up on the high side</li> </ul>	<ul style="list-style-type: none"> <li>Clear away the soil on the high side of the bar so water can run along the bar into the bush. Extra soil can be built up against the lower side of the bar to prevent it moving out of place</li> </ul>
<ul style="list-style-type: none"> <li>Water running over the top of an earthen bar – due to soil building up in the trench, or foot traffic wearing down the bar</li> </ul>	<ul style="list-style-type: none"> <li>Drag soil up onto the top and compact with a rake hoe</li> </ul>

<ul style="list-style-type: none"> <li>Debris building up at the downward end of an earthen bar – allowing water to gather in the trench</li> </ul>	<ul style="list-style-type: none"> <li>Clean out with a rake hoe ensuring the water can run off freely</li> </ul>

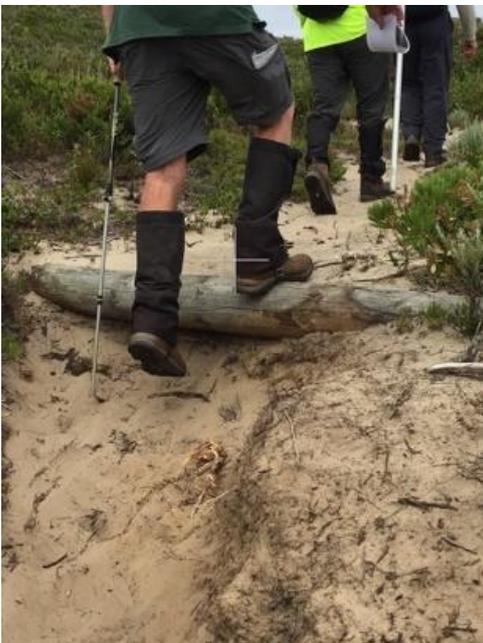
## What is the problem here?

The angle needs to be steeper, so that water is routed off the track. Regular clearing of the upper soil is necessary.
